# **ULTRASONIC INSPECTION OF BRIDGE HANGER PINS**

Benjamin A. Graybeal<sup>1</sup>, Richard A. Walther<sup>2</sup>, SE, PE, and Glenn A. Washer<sup>3</sup>, PE

## **ABSTRACT**

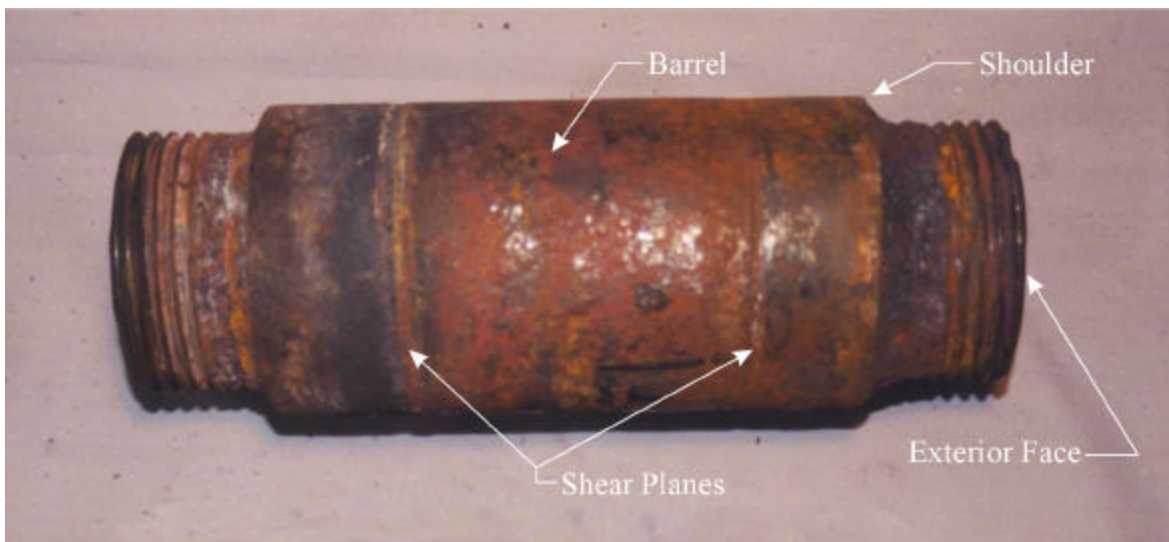
A photograph of one of the hanger pins examined for this study is shown in Figure 2. Note that one of the exterior faces and the shear planes are identified in the figure. The exterior faces are the only surfaces through which ultrasonic pulses can be transmitted while the pin is in situ. The shear planes are the likely locations of defect initiation.

Figure 2. Photograph of hanger pin following removal from bridge.

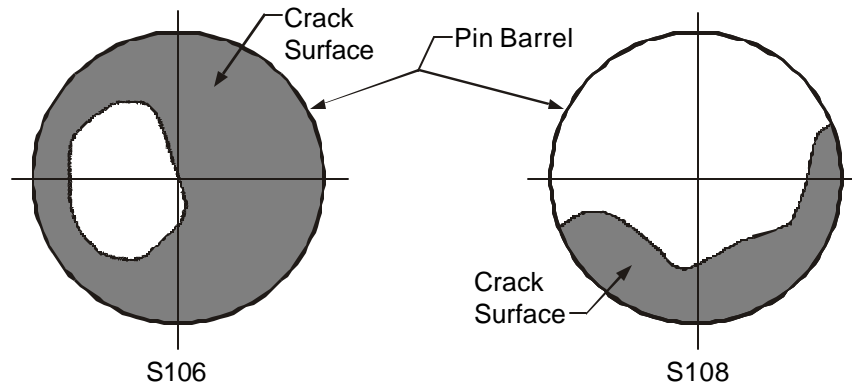
The field inspection indicated that two of the 22 original pins were cracked. This inspection also found five additional pins that had wear groove indications at the shear plane. All seven of these pins were removed from the bridge structure and shipped to the NDEVC. These pins, labeled S104 through S110, are now part of the NDEVC's Component Specimen Database.

This study primarily focused on the two cracked pins. The results from field ultrasonic testing of the two cracked pins, labeled S106 and S108 are shown in Figure 3. The approximate defect profile at the shear plane is indicated in the figure for each pin. The original sketches were produced in the field by hand sketching.

Figure 3. Cracked section results from field ultrasonic inspection.

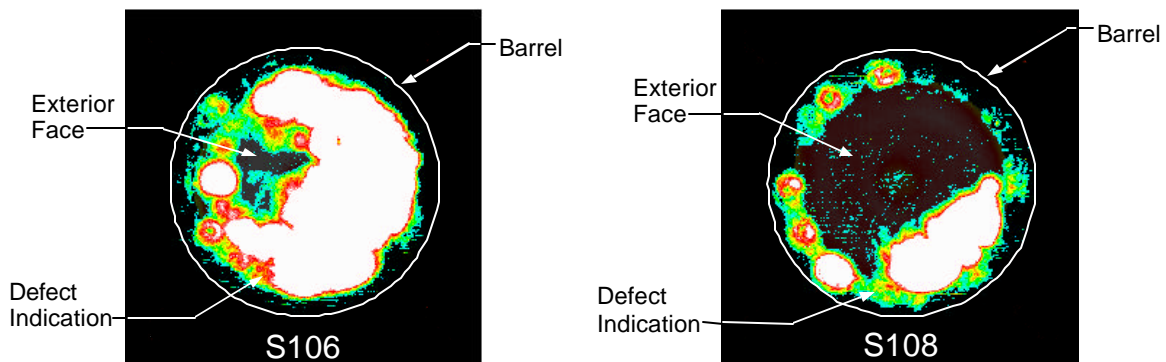
As mentioned previously, the first phase of the detailed testing focused on the identification of the location of defects near the perimeter of the body of the pin. These scans used the same gain, attenuation, and threshold settings as were used for the initial preliminary scans of all seven pins. Through the use of a calibration block, it was determined that these settings allowed for the scan to receive a reflection from a defect at the level of the shear plane which was 6.4-mm (0.25-in) outside of the direct path of the transducer. Accordingly, the procedure could detect a defect that was near the perimeter of the pin body at the level of the shear plane. However, it must be noted that crack-like indications at the limits of this range were difficult to differentiate from wear grooves or corrosion. The results of these scans are presented in the form of a Cscan image in Figure 4a. For reference, the Cscan image of the defects has been superimposed over a darkened Cscan image of the exterior face of the pin. This allows for clear identification of the travel path of the ultrasonic pulse. The outline of the pin barrel is also presented.

a. Defects under pin shoulders at the shear plane level.

Figure 4. Cscan images of defect indications in hanger pins S106 and S108.

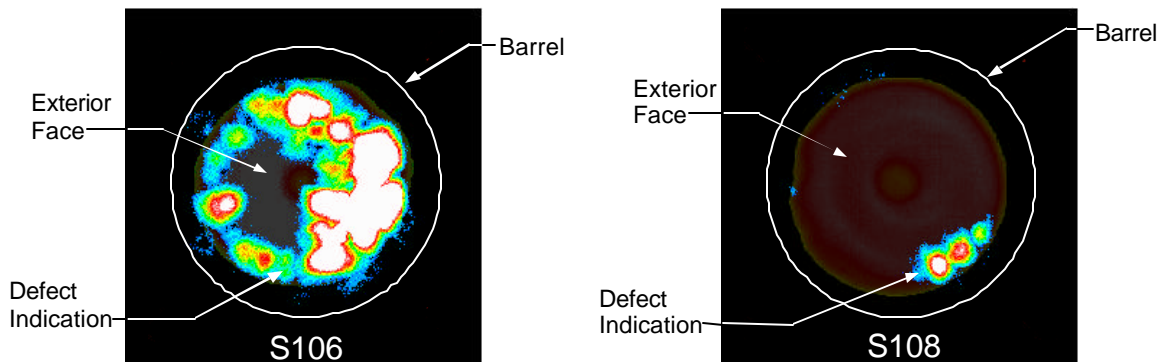
The second phase of the detailed investigation of the cracked shear plane regions was then conducted. The goal of this set of scans was to accurately locate the defects that lay directly under the exterior face of the pin. Using the calibration block, the scans were setup such that only defects that were at least partially under the transducer were reported. The Cscan results for these tests are shown in Figure 4b. Once again, for reference, the exterior face of the pin and the pin barrel are presented.

b. Defects under the pin exterior face at the shear plane level.

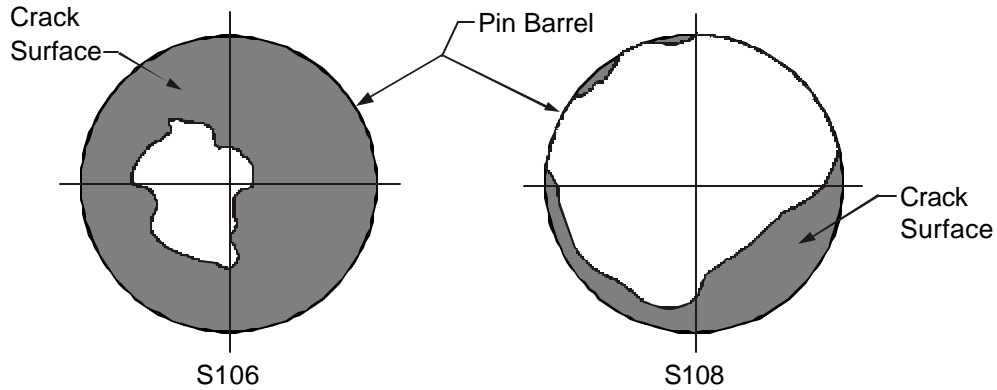
Using the results shown in Figures 4a and 4b, a schematic representation of the defects present at the shear plane level of S106 and S108 can be determined. These results are shown in Figure 5. The cracked portion of the shear plane is shaded in the figure.

Figure 5. Cracked section results from immersion tank ultrasonic inspection.

Comparison between the field ultrasonic results (Figure 3) and the immersion tank ultrasonic results (Figure 5) indicates that the two methods provide similar conclusions as to the extent of cracking at the shear plane level in these two specimens. In pin S106, the immersion tank findings indicated that 79 percent of the cross-section was cracked and the field ultrasonics indicated that 83 percent of the section was cracked. For S108, the immersion tank and field ultrasonic findings indicate 30 and 22 percent of the section was cracked, respectively. Due to the automated nature and the higher spatial resolution of the immersion tank scan, the results from this portion of the testing are believed to provide a more refined and more accurate representation of the extent of the cracking. However, the results from the field ultrasonic testing were found to be quite accurate, given the logistical challenges present in the acquisition of field ultrasonic data.
