GROUND-PENETRATING RADAR AND SHALLOW REFLECTION SEISMIC SURVEYS FOR MITIGATION OF KARSTIC DAMAGE TO I-44 EMBANKMENT, WEST SPRINGFIELD AREA, MISSOURI

*Neil L. Anderson, *Glendon L. Adams, +Gary Goesmann,
+Tim Newton, #Allen W. Hatheway and *Steve Cardimona

+Missouri Department of Transportation, Jefferson City, Missouri
*Department of Geology and Geophysics,
University of Missouri-Rolla, Rolla, Missouri

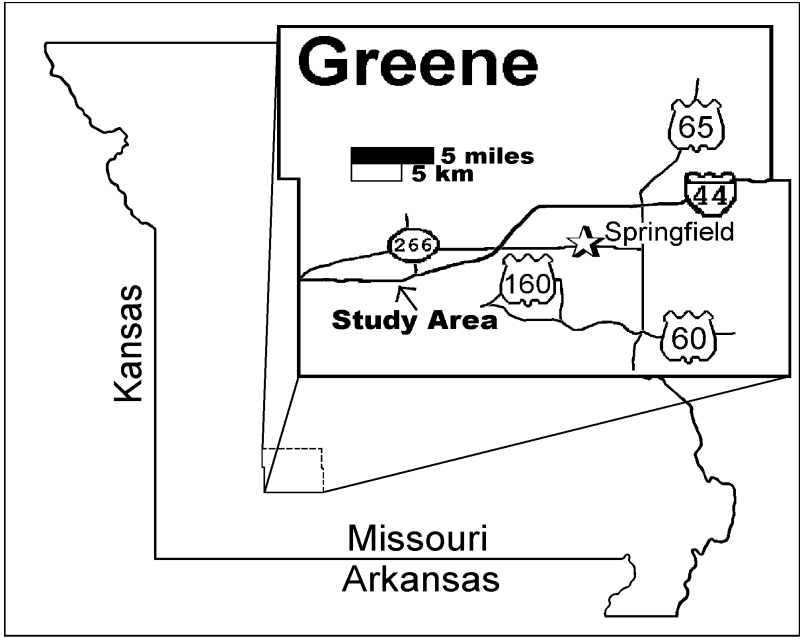
Figure 1: Map of Greene County, Missouri. The distressed section of Interstate 44 is located in west Springfield. The study area is characterized by active and paleo karstic sinkholes.

In May of 1997, UMR conducted two geophysical surveys (1A and 1B) for MoDOT along and adjacent to a distressed section of I-44, in the West Springfield area, Missouri (Figures 1, 2, 3 and 4). This 250 m section of I-44 partially overlies a man-made tunnel and has experienced gradual, but continual and visually-detectable subsidence in areas bordering the paved roadway. Test borings revealed the presence of sub-pavement voids. The surrounding area shows visual evidence of karstic sinkholes. These subsidence features and sub-pavement voids were attributed to karst-related activity, as karstic sinkholes are prevalent in the surrounding area and the runoff waters that flow into the tunnel, drain rapidly through the fractured concrete floor. The sub-pavement voids were attributed to upward-propagating, piping-removal of embankment soil (i.e., washout of the fine-grained fraction of the embankment fill).

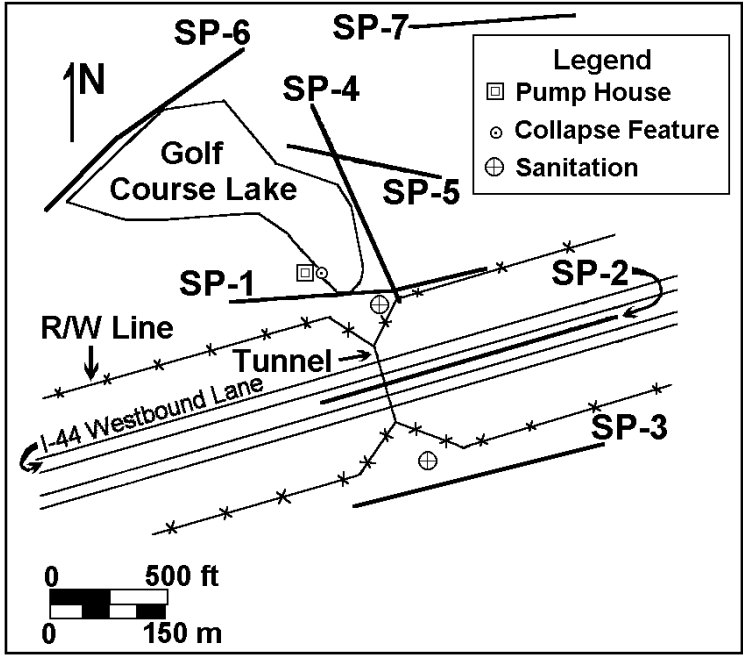
Figure 2: Map of study area, showing locations of seismic profiles SP-1 through SP-7 and GPR areas 1 - 6 (Figure 3). The distressed section of I-44 extends about 200 m from the eastern edge of the underlying golf course tunnel. This section of interstate has experienced continual and ongoing, localized, right-of-way, shoulder and median subsidence of probable karstic-origin. Test borings have revealed the presence of localized sub-pavement voids. The surrounding area shows visual evidence of karstic sinkholes.

In survey 1A, seven reflection seismic profiles were acquired along or near the I-44 embankment (Figure 2). The goal was to map bedrock and identify structural trends in the area, with a view to determining the origin of the localized subsidence features and sub-pavement voids. In survey 1B, thirty GPR profiles were acquired across and along the shoulders of concrete-paved sections of I-44, in places immediately adjacent to minor subsidence features of relatively recent occurrence (Figures 2, 3 and 4). The intent was to locate any sub-pavement voids.

The locations of the seven reflection seismic profiles are shown in Figures 2 and 5. The reflection from bedrock has been correlated across these seismic profiles. Significant bedrock structural lows are interpreted on several of the profiles. The depressions in the bedrock surface are interpreted as karstic collapse, as opposed to top-of-rock erosional features. The more significant seismic interpretations have been superposed on the site basemap, itself prepared by MoDOT District surveyors (Figure 5).

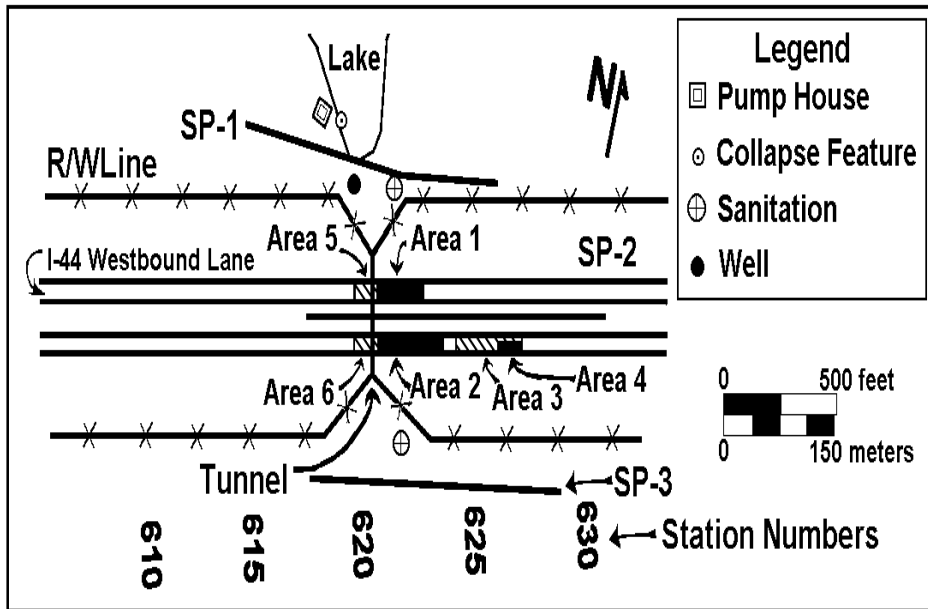
Springfield GPR Line Locations

Figure 3: GPR study areas 1-6 (Figure 4).

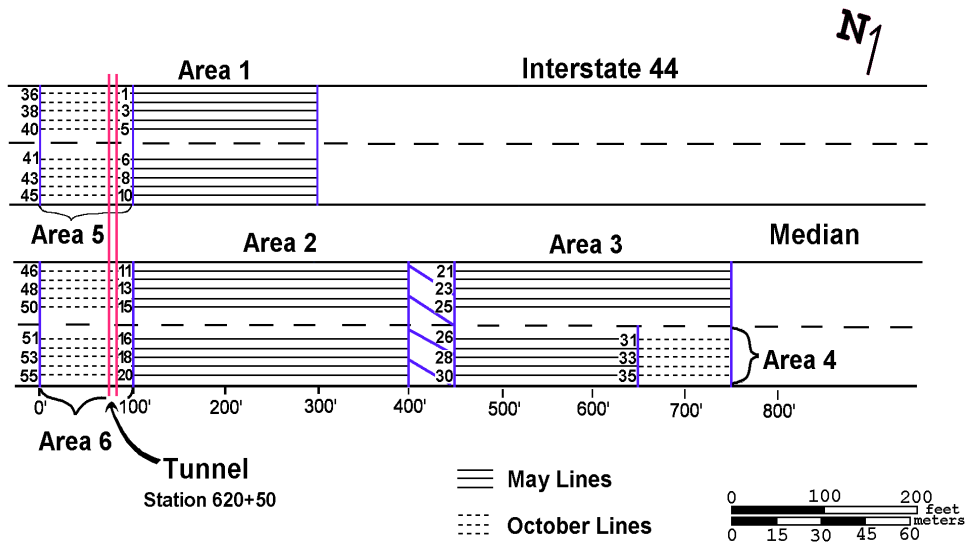
Figure 4: Enlarged map of study area, showing locations of GPR areas 1 – 6 (Figure 3). Duplicate GPR profiles were acquired along traverses 1-30 in both May 1997 and October 1997. Data was acquired along traverses 31-55 only in October 1997.

In May of 1997 (survey 1B), thirty GPR profiles were acquired along paved sections of Interstate 44, in places immediately adjacent to recent subsidence features (lines 1-30; areas 1, 2 and 3; Figures 4 and 8). The intent was to image the shallow subsurface to a depth of about 3 m, to detect possible piping voids. In October of 1997, the study site was revisited (survey 2) and a duplicate set of 30 ground-penetrating radar profiles and 25 additional GPR lines were acquired (lines 31-55; areas 4, 5 and 6; Figure 4). The duplicate set of 30 profiles was acquired to determine the effectiveness of the grouting program and to determine if any new piping voids had developed since the May survey. The 25 additional lines were acquired to extend GPR control into previously untested areas, with a view to identifying any voids (if present).

In October of 1997, geophysical survey 2 was conducted. A duplicate set of thirty ground-penetrating radar profiles and twenty-five additional GPR profiles were acquired (Figures 3 and 4). The duplicate set of GPR profiles was acquired with a view to ascertain the effectiveness of the grouting program and determine if any new voids had developed since the May survey. The 25 additional lines (lines 31-55; areas 4, 5 and 6; Figure 4) were acquired to extend GPR control into previously untested areas, with a view to identifying any substantive voids. The interpretation of these survey 2 data suggests that the grouting program effectively in-filled most of the previously imaged sub-pavement voids. No new, prominent GPR anomalies were observed on either the duplicate data set (30 lines) or the newly acquired coverage (25 profiles across previously untested areas).

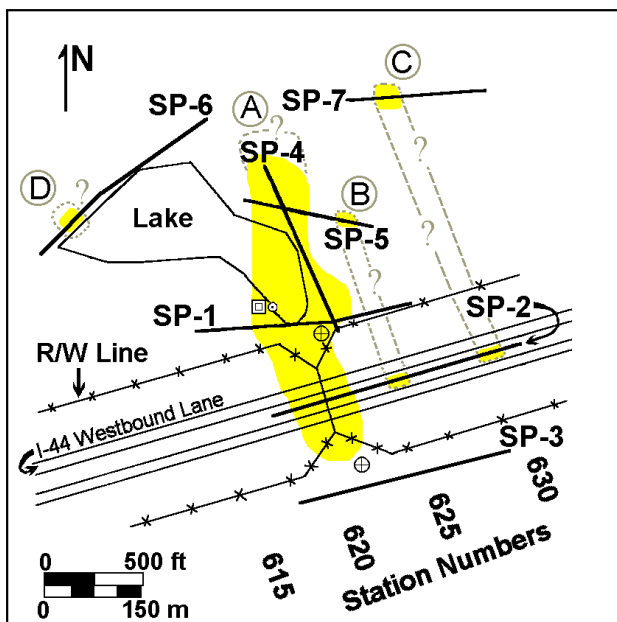
Figure 5: Map of study area, showing interpreted aerial extent of karstic features A through D.

At the time surveys 1A and 1B were conducted, MoDOT engineers were not aware that the distressed section of I-44 overlies an in-filled karstic sinkhole (sinkhole feature A; Figure 5) that was mostly in-filled at the time the Interstate and golf course tunnel were constructed (early 1970's). The presence and areal extent of this in-filled (and apparently reactivated paleokarstic sinkhole) was discovered only when pre-construction topographic maps were examined and compared to the seismic bedrock map. These pre-construction topographic maps and geologic field mapping support the interpretation of the reflection seismic data presented herein.

On the basis of our interpretation of the reflection seismic data, we have identified and mapped several partially in-filled karstic sinkholes in the study area, some of which have been reactivated since the interstate was constructed. The most significant of these are denoted as sinkhole features A, B, C, and D on Figure 5.

The distressed section of I44 mostly overlies two prominent karstic features (features A and B; Figures 5, 6 and 7). Feature A appears to represent an elliptical or elongate, north-northwest trending karstic sinkhole. The southern part of this feature was mostly in-filled with embankment materials when the Interstate and golf course tunnel were constructed. The northern section was selected as a topographic low for the 1993-placement of the nearby golf-course irrigation pond and earth-fill dam (Figure 5). The interpretation of lines SP-2 and SP-3 suggests that the karstic sinkhole extends southward beneath the Interstate, but that it does not extend across profile SP-3 (Figures 5 and 7). This interpretation is consistent with the pre-construction topographic maps.

In-filled paleo karstic sinkhole B is imaged only on seismic profile SP- 5. The shear zone system along which sinkhole B developed appears to extend beneath the interstate (Figures 5 and 6). The correlation between areas of surface distress and seismic evidence of karstic sinkhole development, supports our interpretation that distress is caused by the downward seepage of run-off waters through the highway median, and possibly pond leakage from the unlined golf course lake. The sub-pavement voids are thought to be caused by the upward-propagating, piping-removal of embankment soil (i.e., washout of the fine-grained fraction of the embankment fill) mostly through karstic feature A.

Karstic sinkhole C is imaged on seismic profiles SP-2 and SP-7 (Figure 5). It is characterized by recent surface subsidence immediately adjacent to profile SP-7, however sub-pavement voids were not detected along I-44 immediately above feature C. There is no evidence to suggest sinkhole C has been reactivated in the immediate vicinity of I-44, or that it constitutes a potential long-term threat (re: highway stability).

Active sinkhole D is manifested as recent collapse features (mapped in field studies), and is imaged on Seismic SP-6 (Figure 5). The shear zone systems along which this sinkhole developed could extend beneath the interstate, however, neither surface subsidence nor evidence of sub-pavement voids have been observed along the projected south-southeast extension of this sinkhole, and further investigation at this time is probably not warranted.

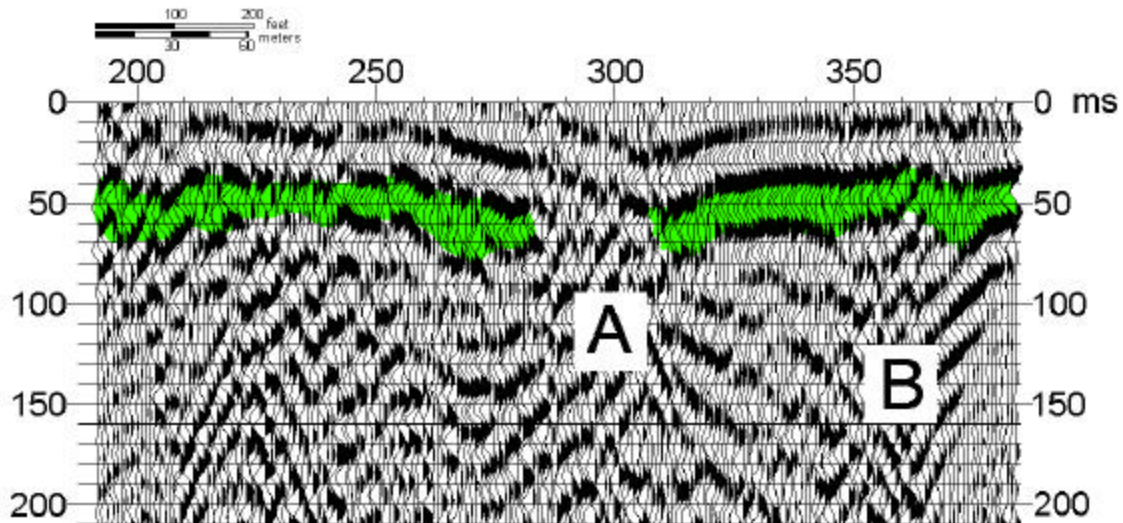
Figure 6: Reflection seismic profile SP-1.

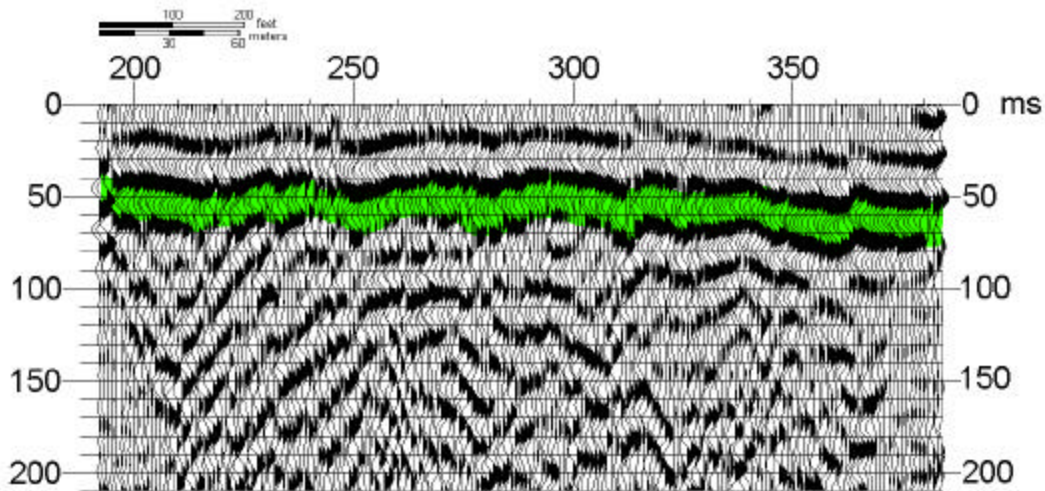
Figure 7: Reflection seismic profile SP-3.

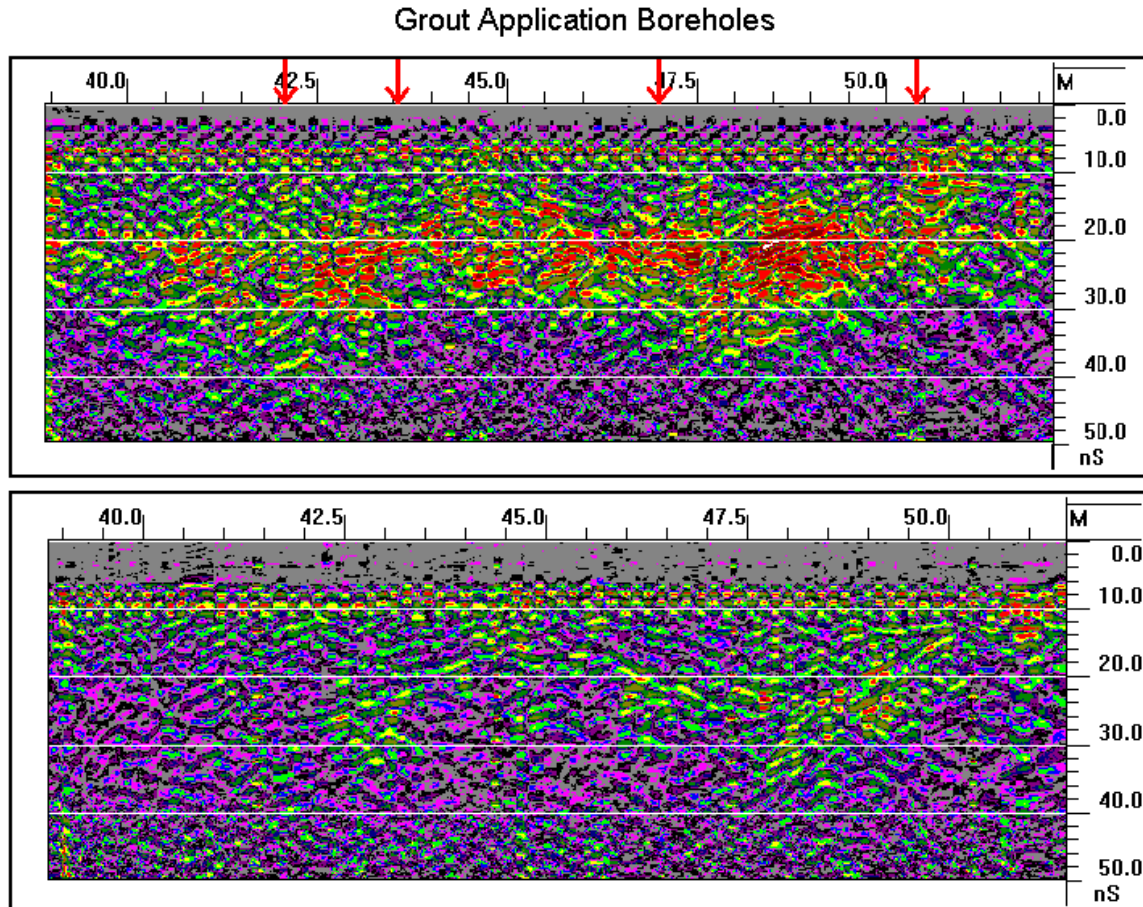
Figure 8: Survey 1B (upper) and survey 2 (lower) segments of GPR profile 2 (Area 1; Figure 3). Interpreted sub-pavement voids are characterized by high amplitude, prominent diffraction patterns on the upper GPR profile (Survey 1B). These diffractions are conspicuously absent on the Survey 2 GPR profile, suggesting that the grouting program effectively in-filled the identified sub-pavement voids. The vertical arrows depict the locations of grout application boreholes.

Two sets of GPR data (surveys 1B and 2) were acquired at the subsidence site, Interstate 44, Springfield Missouri. In survey 1B, thirty GPR profiles were acquired along paved sections of Interstate 44, in places immediately adjacent to recent subsidence features (profiles 1-30; Figures 4 and 8). On the basis of the interpretation of these data, MoDOT personnel were able to locate voids that had developed beneath the pavement (as a result of the washout of fine-grained sediment), and devise an effective grouting plan. Sub-pavement voids are characterized by high amplitude events on the GPR profiles (Figure 7). All areas designated as anomalous (i.e., overlying sub-pavement voids) accepted grout.

An example set of original and duplicate GPR profiles is shown as Figure 8. The high-amplitude diffractions observed on the survey 1B data set, are conspicuously absent on the survey 2 data set, suggesting that the grouting program effectively in-filled the sub-pavement voids.
