# **SURFACE GEOPHYSICS AS TOOLS FOR CHARACTERIZING EXISTING BRIDGE FOUNDATION AND SCOUR CONDITIONS**

Michael L. Rucker, P.E.

AMEC Earth & Environmental, Inc., 1405 West Auto Drive  
Tempe, Arizona 85284; [michael.rucker@amec.com](mailto:michael.rucker@amec.com)

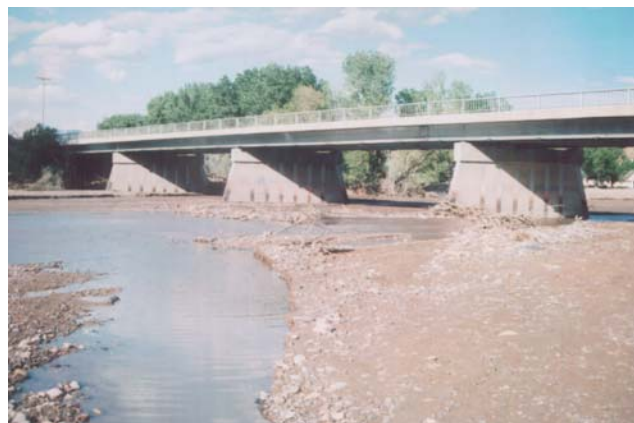
**Figure 1.** Beaver Dam Wash Bridge (Piers 2, 3 and 4) in Northwest Mohave County, Arizona after winter 2005 flood. Surface seismic lines were completed between each set of piers and abutments. Surface resistivity was completed at a previously installed piezometer on a gravel bar in the northern portion of the stream channel bed.

In January 2005, a major flood in Beaver Dam Wash caused significant erosion to channel banks, the approach and south abutment of the Beaver Dam Wash Bridge on Mohave County Highway 91 in northwestern Arizona (AMEC, 2005a). As a result, the width of the channel at the bridge was widened by approximately 180 feet (55 m) at the south abutment. There were concerns related to the structural integrity of the bridge and the owner requested a thorough evaluation of the bridge. The existing structure, constructed in the 1950's, is a 2-lane bridge constructed of reinforced concrete and is approximately 330 feet (100 m) in length (Figure 1). The five-span structure is supported on driven H-piles at both abutment and pier locations. Geotechnical data contained within the as-built drawings was limited to basic soil descriptions and approximate depths at each boring location. At the time of the original investigation, the upper roughly 2 to 10 feet (0.6 to 3 m) of river channel deposit consisted of loose sand, overlaying 10 to 18 feet (3 to 5.5 m) of sand and gravel, with occasional sand and boulders at depth. Plans indicated that each boring was terminated 2 to 3 feet (0.6 to 0.9 m) into a clayey cobble and boulder deposit. Both abutments and piers were constructed on driven vertical and battered H-piles driven to depths ranging from 40 to 47 feet (12 to 14 m). At the abutments, sheet pile walls surrounding the abutments extended to 25 feet (7.6 m) below constructed grade. It is anticipated that the river channel elevations have varied somewhat since the surveys were performed in 1951 and, therefore, may not reflect existing conditions. Following the 2005 flood event, initial investigation at the bridge consisted of two borings advanced to depths of 22 and 27 feet (6.7 to 8.2 m). The soils encountered in the borings were typically sands and silty sands with some to considerable gravel, with relative density of encountered soils typically moderately dense to very dense in zones. The borings were terminated when auger and sample refusal occurred, and estimated depths of scour were highly varied between the borings. One boring was completed as a piezometer, and groundwater was recorded a depth of 1 to 2 feet (0.3 to 0.6 m).

Broader coverage of the site subsurface conditions was then accomplished using surface seismic methods. Six combination seismic refraction (p-wave) and refraction microtremor or Remi (s-wave) surveys, were performed between piers and abutments under the bridge (with one survey upstream), with the intent of determining the extent of low-seismic velocity scourable materials within the channel. The seismic lines were completed utilizing a Geometrics S-12 signal enhancement engineering seismograph and an array with 10-foot spacings between 4.5 Hz geophones (Figure 2). Useful compression wave (p-wave) depths and velocities could not be attained because of the shallow depth to groundwater. P-wave depth and velocity interpretations were consistent with the top of the water table at a depth of 1 to 2 feet (0.3 to 0.6 m) and not with the subsurface profile. However, one-dimensional vertical shear wave (s-wave) profiles at each seismic line were obtained by utilizing traffic over the bridge and jogging alongside the geophone array to generate energy for Remi analysis. An electrical resistivity sounding utilizing a standard four-point Wenner array with electrode spacings of 5, 10, 20 and 30 feet (1.5, 3, 6 and 9 m) was completed at the previously installed PVC-cased piezometer near the north end of the bridge.

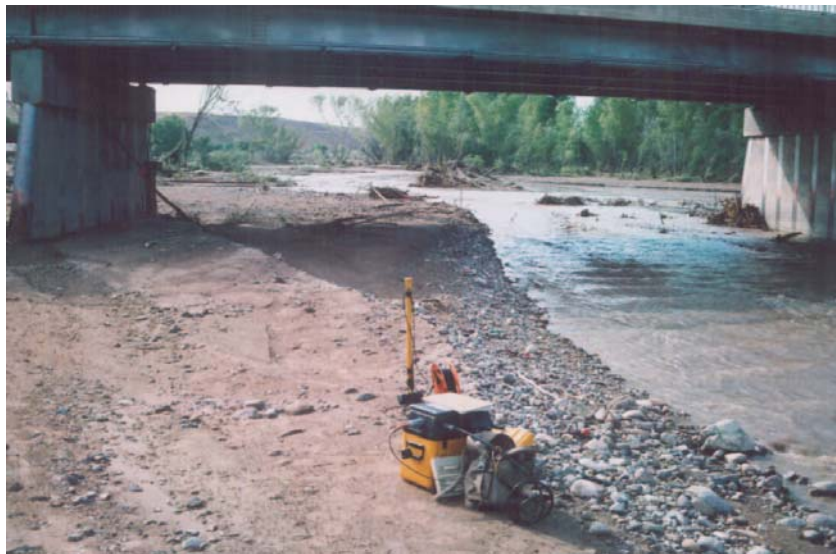
**Figure 2.** *seismograph with 4.5 Hz geophone array deployed along active stream bank under bridge. P-wave data was collected using the sledgehammer energy source with the instrument set to 0.063 msec sample intervals and 256 msec sample period. S-wave data was collected using jogging alongside the array and traffic noise on the bridge with the instrument set to 1 msec sample intervals and a 12 second sample period.*

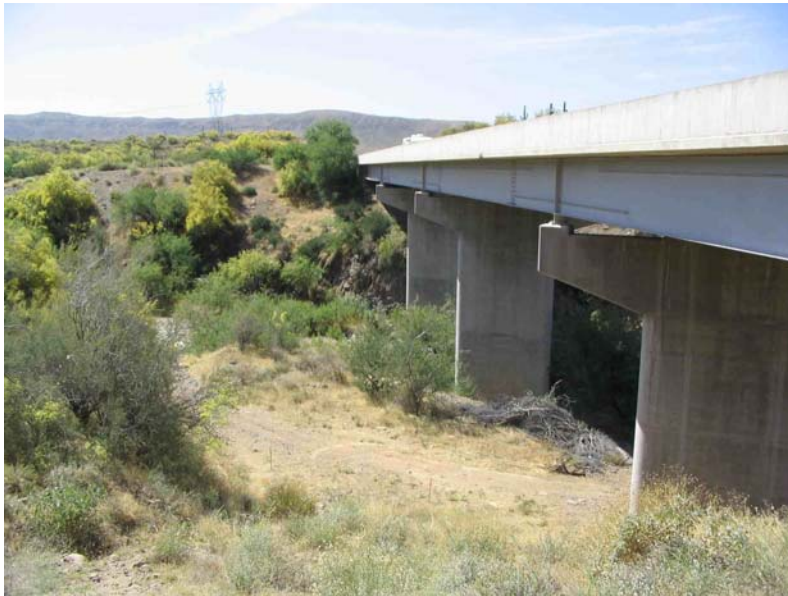
**Figure 5.** *Little Squaw Creek Bridge, constructed in the 1960's, is a 2-lane, 5-span, 315-foot (96 m) long bridge constructed of reinforced concrete. The structure is supported on spread footings at both the south abutment and pier locations. Seismic lines were completed at or between Piers 1 and 2 in or near the active channel. Equipment was hiked into the small canyon from the vehicle parked by the highway.*

Surface seismic was utilized in a geotechnical re-evaluation of pier foundation conditions (AMEC, 2005b) of the existing northbound Little Squaw Creek Bridge (figure 5) on Interstate I-17 south of Rock Springs in central Arizona. The purpose of this investigation was to re-evaluate pier foundation conditions compared to the original design investigation, evaluate potential scour depths at the bridge, and provide particle size distributions of streambed materials for use in hydraulic and bridge foundation analysis as part of a scour retrofit for the bridge. Three combination seismic refraction and Remi lines were performed in order to determine the depth to bedrock and characterize the resistance to erosion of the bedrock at Piers 1 and 2 straddling the active stream channel, and characterize the extent of low seismic velocity / scourable materials adjacent to Piers 1 and 2 and within the existing stream channel between these piers. The seismic lines were completed utilizing the Geometrics S-12 seismograph and geophone

Piers 1 and 2 straddled the channel of Little Squaw Creek. Pier 1 was on the south side of the stream channel about 7 to 10 feet (2.1 to 3 m) from a steep outcrop of Precambrian Schist forming the south boundary of the creek channel. An active channel in the stream center was about 20 feet (6 m) wide and had a small amount of water flowing in it. This active channel consisting of gravels, cobbles and small boulders was considerably coarser than the adjacent channel floodplain bank deposits that consisted primarily of sand, gravel and cobbles. To the north of Pier 2 towards Pier 3, fill was observed to form the north boundary of the stream channel. Piers 3 and 4 were not of concern in this investigation.

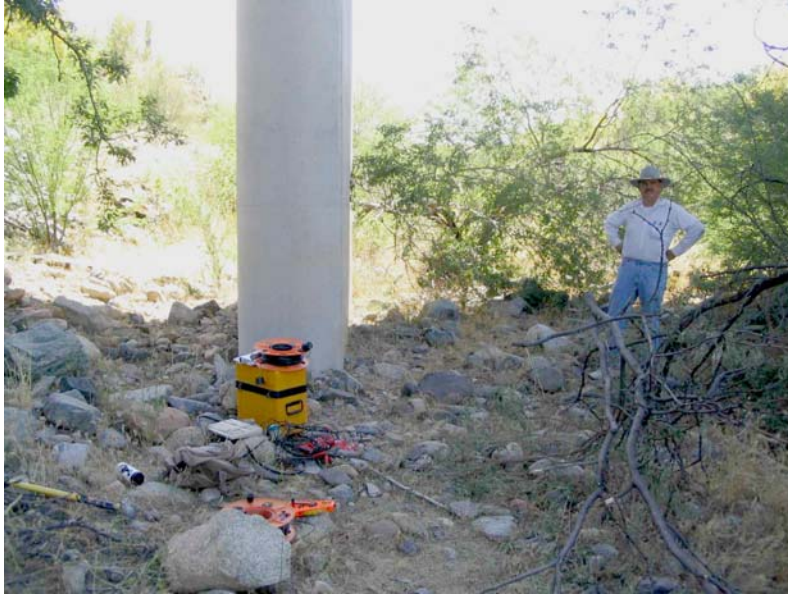
**Figure 6.** Starting location of the seismic line adjacent to Pier 2. Results of this line are presented in Figure 7. Note very coarse particles in the streambed. A scan line using a 100-foot (30 m) cloth tape was performed at this location to provide a very coarse particle size distribution.  $D_{50}$  and  $D_{95}$  for the surface particles were 0.5 and 11.2 inches (12.5 and 284 mm), respectively. The largest particle counted had a b-axis dimension of 17.3 inches (440 mm).

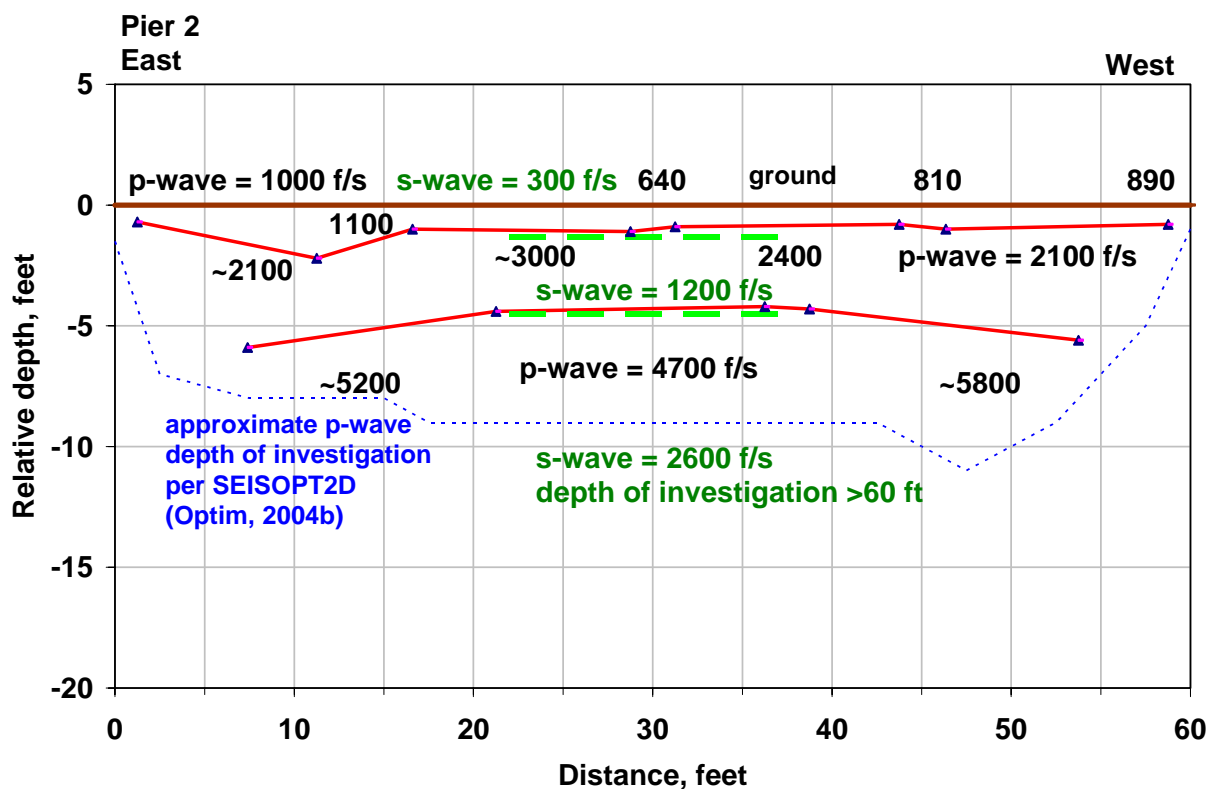
**Figure 7.** Seismic profile at Pier 2. Depths and distances are in feet, and p-wave and s-wave velocities are in feet/second. The horizon at 1 to 5 foot (0.6 to 1.5 m) depth (p-wave 2,100 to 3,000 f/s, s-wave 1,200 f/s; 640, 910 and 370 m/s, respectively) is consistent with SGC above water table. Below 5 foot (1.5 m) depth (p-wave 4,700 to 5,800 f/s, s-wave 2,600 f/s; 1,400, 1,800 and 790 m/s, respectively) is consistent with fractured, weathered bedrock or clayey SGC.

Underlying the SGC deposit at Pier 2, rock or rock-like material with p-wave velocities of 4,700 to 5,800 f/s (1,400 to 1,800 m/s) was interpreted. Such p-wave velocities could indicate relatively competent material or a saturated SGC material below the groundwater table. Corresponding s-wave velocities underlying the SGC deposit increased to about 2,600 f/s (790 m/s). The increase in s-wave velocity indicated that relatively competent material was present underlying the SGC and that the p-wave velocity increase was not due solely to groundwater.

Based on sketches of existing pier foundation conditions and the results of the seismic investigation, it appeared that the spread footing of Pier 1 was founded on rock (p-wave velocity ~11,000 f/s or 3,400 m/s, s-wave velocity ~2,600 f/s or 790 m/s) and the spread footing of Pier 2 was founded on rock or rock-like material (p-wave velocity ~5,000 f/s or 1,500 m/s, s-wave velocity ~2,600 f/s 790 m/s). Shallow rock (p-wave velocity ~7,300 to 9,600 f/s or 2,200 to 2,900 m/s, s-wave velocity ~3,500 f/s or 1,070 m/s) was present under the thin gravel cobble material in the active channel. Based on the geophysical interpretations, it was estimated that the upper roughly 4 to 6 feet (1.2 to 1.8 m) of material at Piers 1 and 2 were cohesionless, primarily coarse granular materials that may be subject to scour if sufficient hydraulic energy is applied. Rock or rock-like materials underlying the coarse cohesionless SGC horizon, and upon which Piers 1 and 2 are founded, are anticipated to be much more resistant to scour erosion.

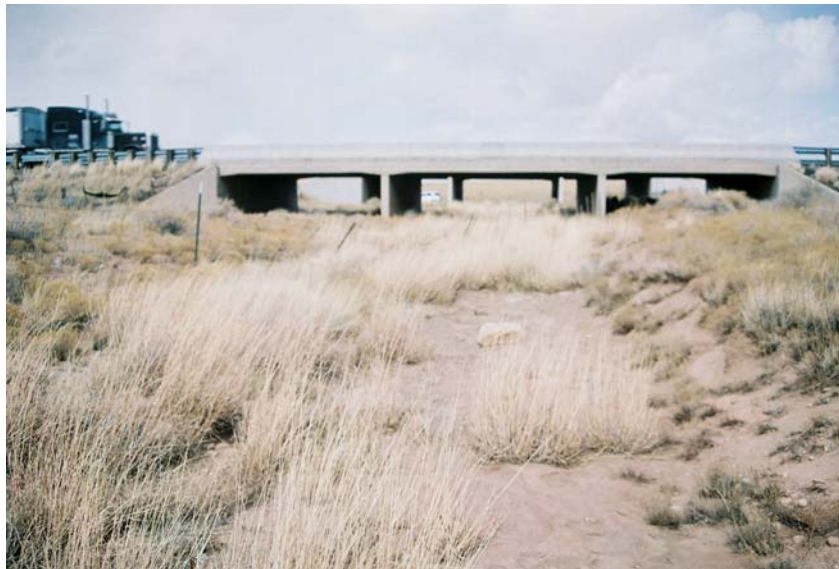
**Figure 8.** *East-bound Babbitt Tanks Wash Bridge is in foreground looking north. Piers 1 and 2 are located in or adjacent to the active channel of Babbitt Tanks Wash. Based on the 1944 plans, pier foundations are three-foot (0.9 m) wide strip footings that are 18 inches (0.46 m) thick. Plans showed footing bottoms set approximately six inches (0.15 m) below the "Probable Solid Rock Line."*

Surface seismic was utilized for a geotechnical evaluation of pier foundation conditions eastbound Babbitt Tanks Wash Bridge (Figure 8) in the vicinity of Meteor Crater on Interstate I-40 east of Flagstaff in northern Arizona. The purpose of this investigation was to evaluate pier foundation conditions and evaluate potential scour depths at the bridge across an indistinct ephemeral drainage, and provide particle size distributions of streambed materials for use in hydraulic and bridge foundation analysis as part of a scour assessment for the bridge (AMEC, 2006). The existing bridge, constructed in the 1940's, is a 2-lane, 3-span, 80 foot (24 m) long reinforced concrete structure supported on spread footings at both the abutments and two pier locations. No geotechnical data concerning foundation conditions was available beyond a "probable solid rock line" on the plans.

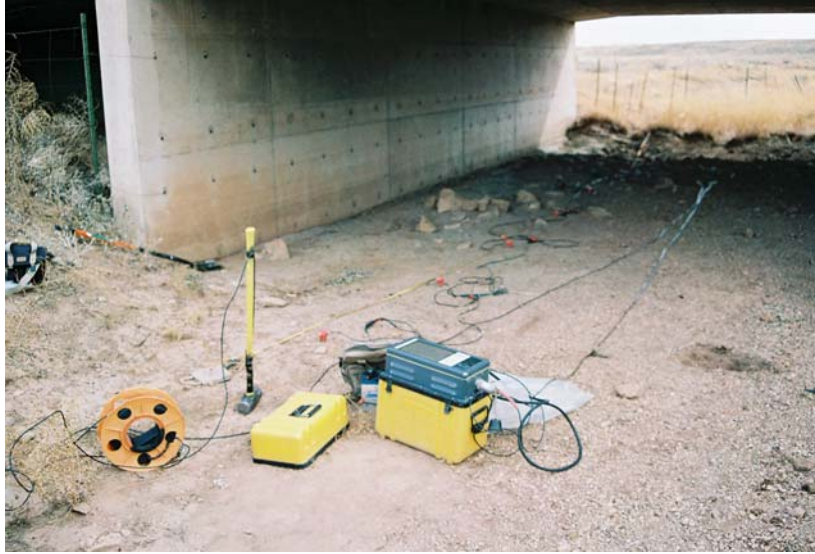
**Figure 9.** *Surface seismic setup under bridge. Unlike the typical channel upstream, considerable coarser material was exposed at the surface under the bridge. The tops of the pier footings were generally exposed under the bridge but were covered at ends of the piers. The channel bottom appeared to be several inches higher than the tops of the footings; the ground surface grade and sloped to the footings.*

Two combination seismic refraction and refraction microtremor lines were performed at selected locations near Piers 1 (Figure 9) and 2 in the active channel under the bridge. The seismic lines were performed in order to determine the depth to bedrock and characterize the resistance to erosion of the bedrock, and characterize the extent of low seismic velocity / scourable materials adjacent to the piers and within the existing stream channel between the piers. The seismic lines were completed utilizing the Geometrics S-12 seismograph and 4.5 Hz geophone arrays with geophone spacings of 5 feet (1.5 m). Energy sources were sledgehammer for p-wave data and jogging and ambient highway traffic for Remi data. Surface particle scan lines for coarse particle size distribution and bulk samples for particle size analysis were also obtained.

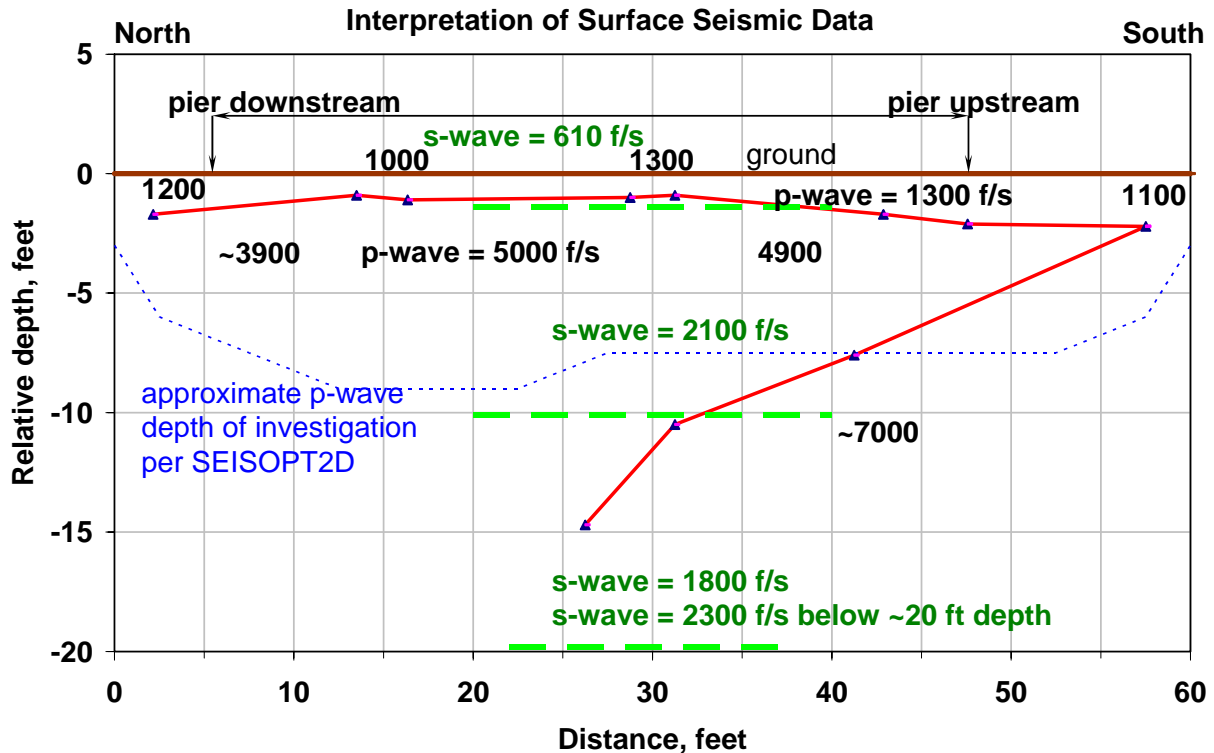
**Figure 10.** Interpreted seismic profile at line shown in Figure 9 with depths and distances in feet and p- and s-wave velocities in feet/second. P-wave velocities in the scour resistant horizon originally characterized as “probable solid rock” varied across the profile and were lower towards the downstream end of the pier. The interpreted s-wave velocity, being limited to a one-dimensional profile, reflected the more erodable lower p-wave velocity in that horizon. A somewhat lower s-wave velocity horizon was interpreted beginning at a depth of about 10 feet (3 m).

Based on as-built plans of existing pier foundation conditions and the seismic results, it appeared that the spread footings of Piers 1 and 2 were founded on relatively soft rock with p-wave velocities ranging from 3,300 to 5,000 f/s (1,000 to 1,500 m/s) and s-wave velocities of about 2,100 to 3,100 f/s (640 to 940 m/s). Results near Pier 1 are presented in Figure 10. It can be anticipated that a rubber-tired backhoe with excavation equipment less than 100 hp or 75 KW (such as Case 590 Super M at 99 hp or a Cat 416c at 78 hp) will encounter refusal in geo-materials with p-wave velocities of about 3,000 to 3,300 f/s or 910 to 1,000 m/s (Stacy and Noble, 1975; Rucker and Ferguson, 2006). As summarized in Table 1, geo-materials with progressively higher p-wave velocities require more powerful equipment for effective excavation. At a p-wave velocity of 5,000 f/s (1,500 m/s), it is anticipated that heavy equipment with available power greater than 300 hp or 220 KW (such as a Cat D8L at 335 hp or Cat 345BL at 321 hp) would be needed for effective excavation. Thus, excavation to 'refusal' for bottom of footings would be consistent with placing the footings on soft rock. Soft rock consisting of limestone can be considered to be similar in behavior to strongly cemented soils or caliche as described in Rucker and Ferguson (2006).
